Rehabilitation of Existing Sewerage Infrastructure

PJ Lyons

**This project is submitted in part fulfilment of the HETAC
requirements for the award of Masters of Science in
Environmental Protection**

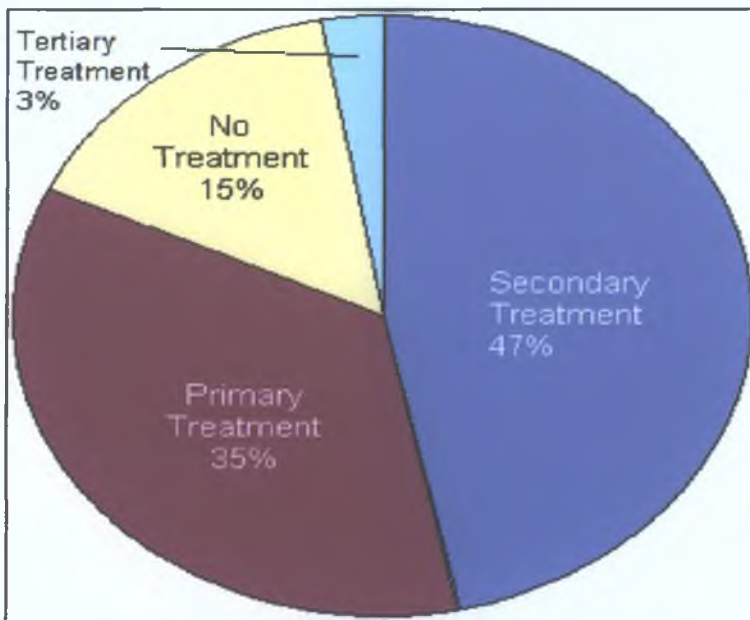
Fig 2.1 A Pie Chart showing the various treatment of domestic sewage in Ireland.

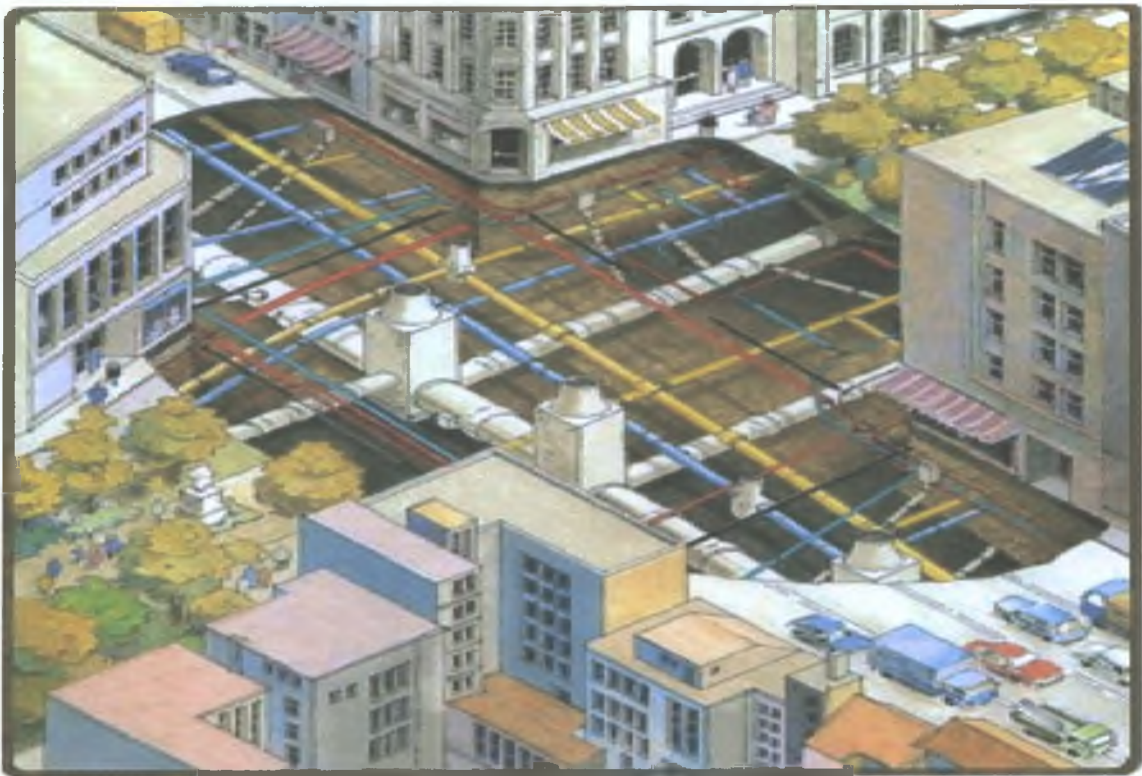
Fig 4.1 Typical underground infrastructure in an urban area

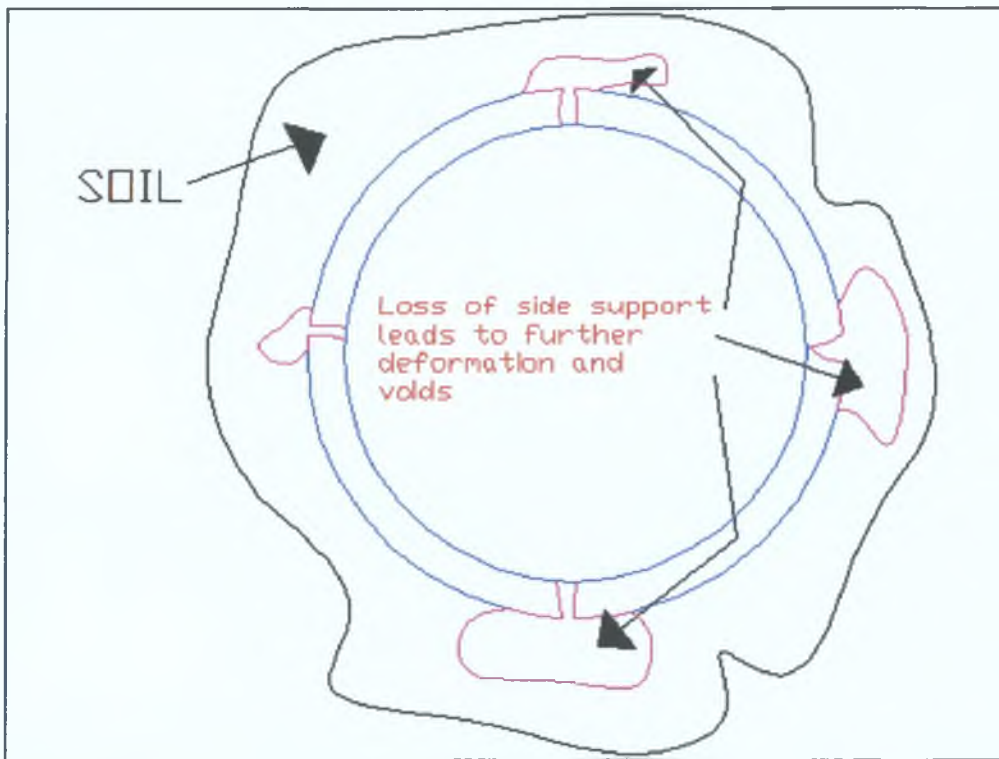
Fig 4.5 Progressed stages of deformation

The resulting deformation will cause cracks and fractures to develop at the highest point of bending stress – which usually occur in the invert and soffit. See Figs 4.4 and 4.5.

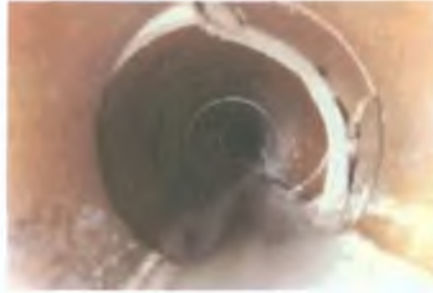
Fig 4.7 Root intrusion within a sewer pipe.

Where a sewer is above the water table there is a risk of roots from nearby trees penetrating the sewer pipe. Root intrusion is not considered a serious structural fault but serious damage occurs when they exacerbate existing defects such as cracks. This may eventually cause blockages and surcharging within the sewer pipe, which will accelerate overall deterioration within the sewer pipe.

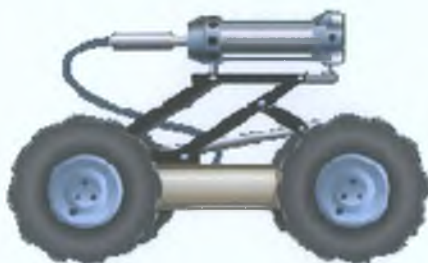
The basic principle of CCTV inspections is that a camera is mounted onto a suitably sized tractor, which is then maneuvered in the pipeline from manhole to manhole from a remote control position. A CCTV camera is mounted on the tractor and the image from the camera is transmitted through an attached cable and is recorded onto a videocassette. The cable is connected up to a colour TV monitor that is installed in the control vehicle, which is usually parked over the manhole is being inspected. The entire survey of the sewer pipe can then be examined from the videotape, where the client can see the sewer pipes defects, infiltration points, flow rates and other features of the pipe.

Fig 5.1 **CCTV camera mounted on a tractor**

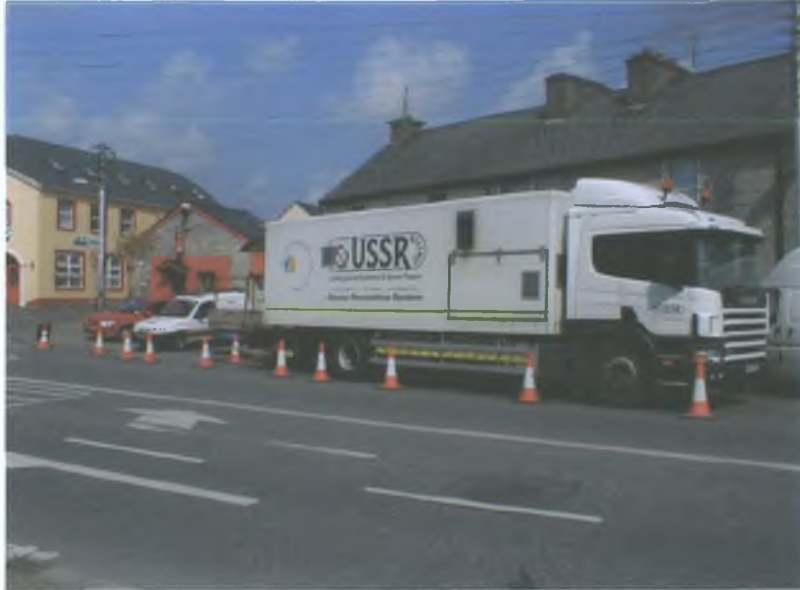
Photo 1.
Typical rehabilitation truck working over manhole.

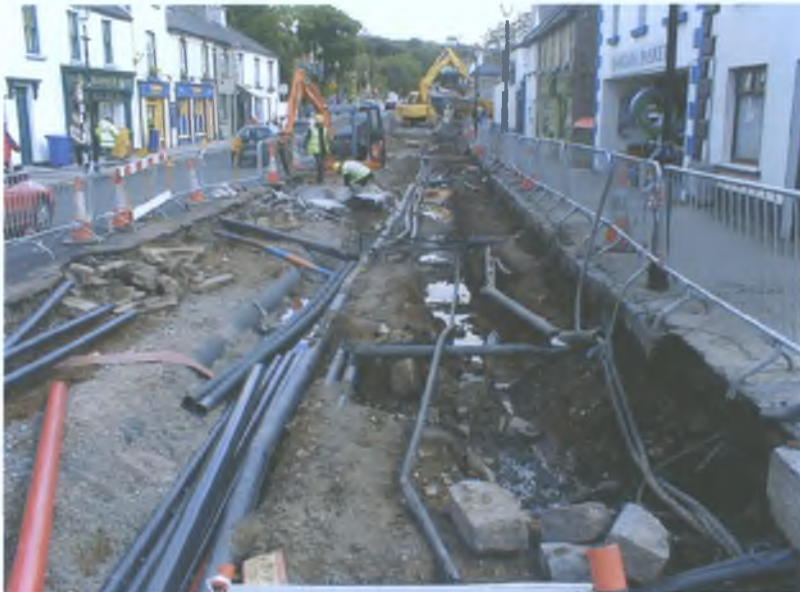
Photo 2.
Typical open cut trench.

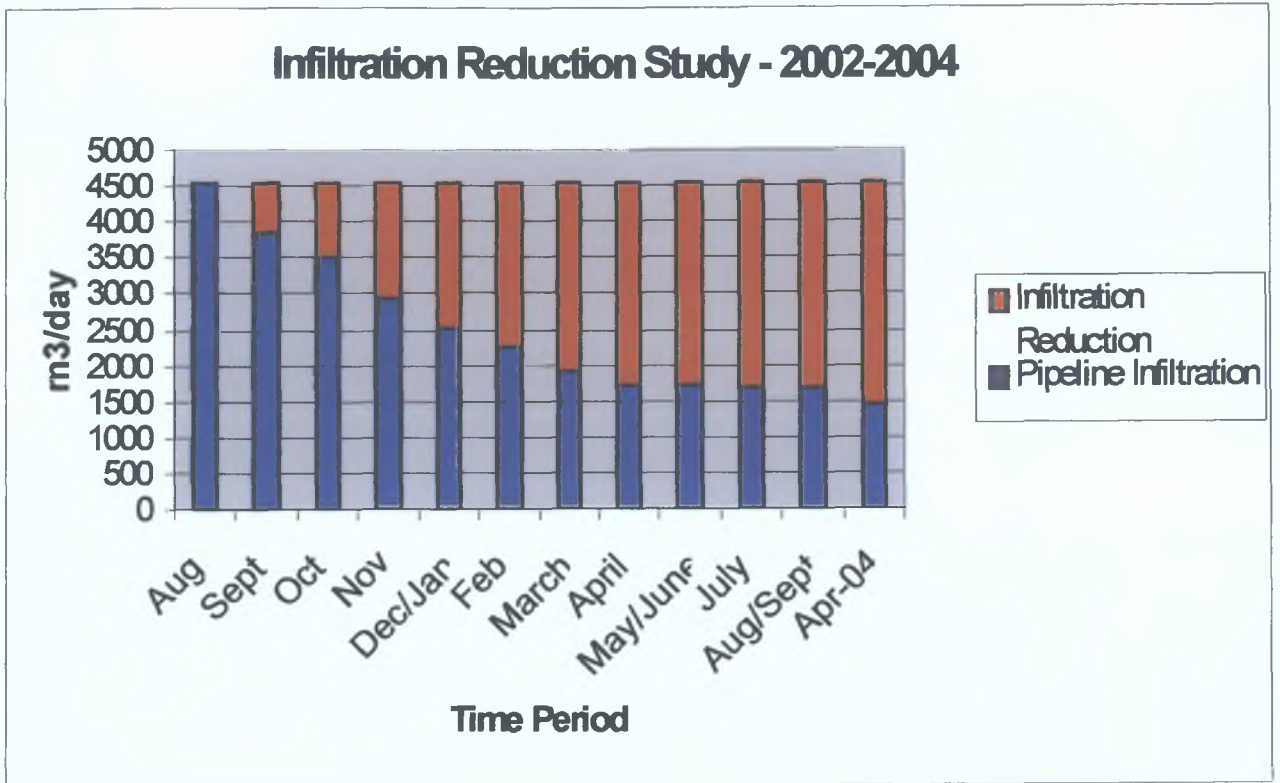
The Attached bar chart shows the Infiltration Reduction Study up to April 2004. The Blue colour shows the infiltration rate and the Red shows the infiltration reduction. The X axis shows the time in months and the Y axis gives the volume of infiltration in m³ x 1000.
